STATE OF THE ART IN STABILITY OF RC STRUCTURAL WALLS

ABSTRACT

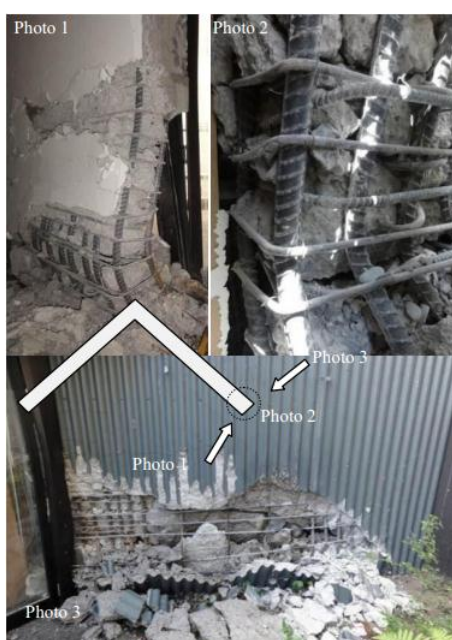
Figure 1 shows the RCSW of a seven-storey office building that experienced local buckling during the 2011 New Zealand earthquake. The failure was attributed to flexural tension yielding followed by instability of the plastic hinge region (Kam, Pampanin, & Elwood, 2011).

Figure 1 Local buckling damage of a RCSW in a seven-storey building during the 2011 New Zealand Earthquake. (Kam, Pampanin, & Elwood, 2011)

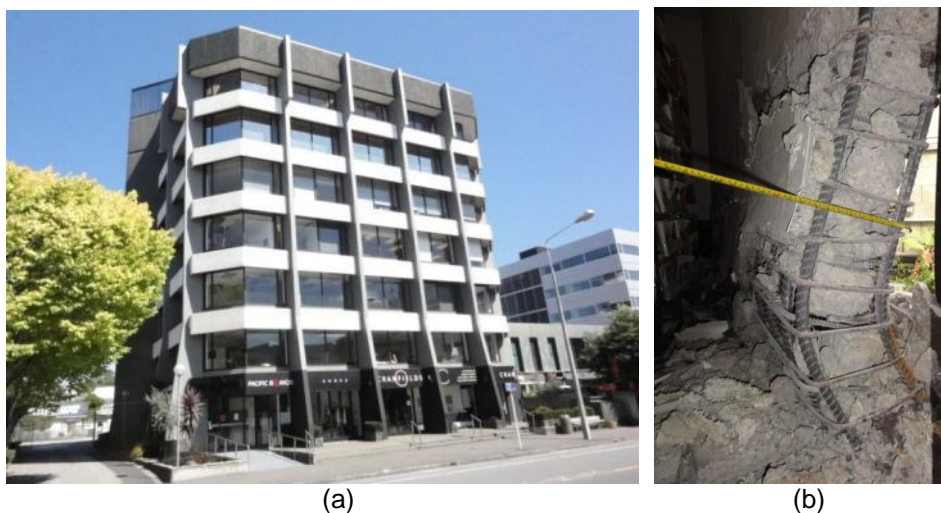
Figure 4(a) and (b) shows the overall view and the structural performance a wall in the Pacific Brands House (PBH), respectively. The PBH was a 7-storey RC building constructed in 1984 which included 2 L-shaped walls of about 300 mm thick. The boundary element of the north wall in the lower level developed an out-of-plane buckling failure, which was accompanied by significant concrete damage on its surrounding areas. The cyclic combinations of compression strains preceded by large tension strains were assumed to be the cause of this phenomenon (Sritharan, et al., 2014). Contrary to what was exposed for the 2010 Chile Earthquake, the PBH building included thicker RC walls but a lower ratio of these structural elements against the total plan area.

Figure 4 RC 7-storey building in Christchurch: (a) Overall view of the building; (b) wall local buckling failure (Sritharan, 2011)

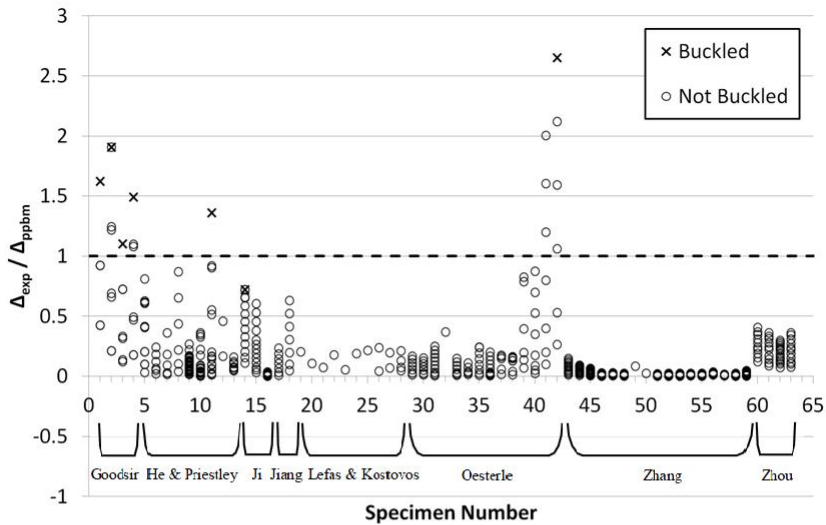
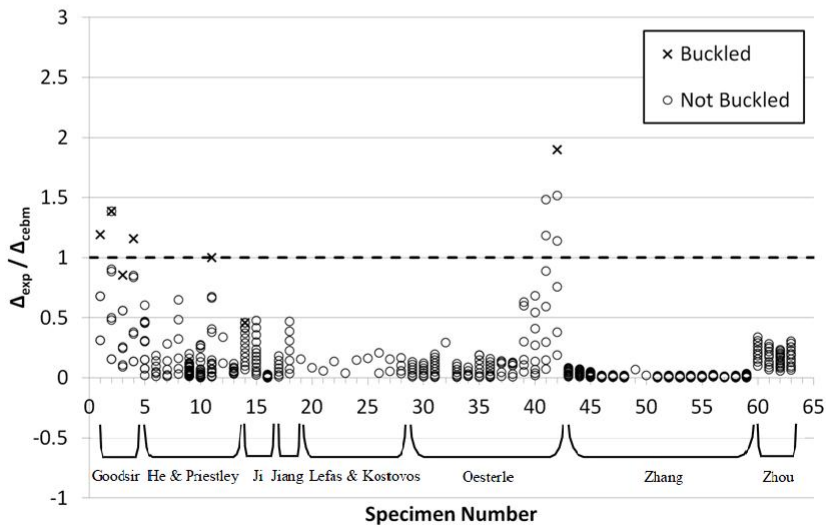
walls included in Herrick’s database when subjected to reversed cyclic loading. These experimental values were normalized to the displacements calculated from PPBM and CEBM associated with the maximum longitudinal tension strains sustained prior to buckling. A moment curvature sectional analysis program, CumbiaWall, was used for this purpose. Note that the prediction of the CEBM agrees better than the PPBM. It is important to mention that some walls from Herrick’s database were not tested with the purpose of capturing inelastic buckling.

(a) Normalized to PPBM displacements

(b) Normalized to CEBM displacements

Figure 8 Wall experimental displacements normalized to PPBM and CEBM displacements. (Herrick, 2014)

Note that monotonic loading cases were set as “zero” in both examinations, for walls and prisms. The symbol ‘x’ represents cycles where buckling instability was detected, and ‘o’ denotes the cycles where buckling was not captured. The specimens were assumed to suffer a buckling failure mode after detecting significant loss of strength, in the range between 10% and 30%, accompanied by a visible out-of-plane displacement.

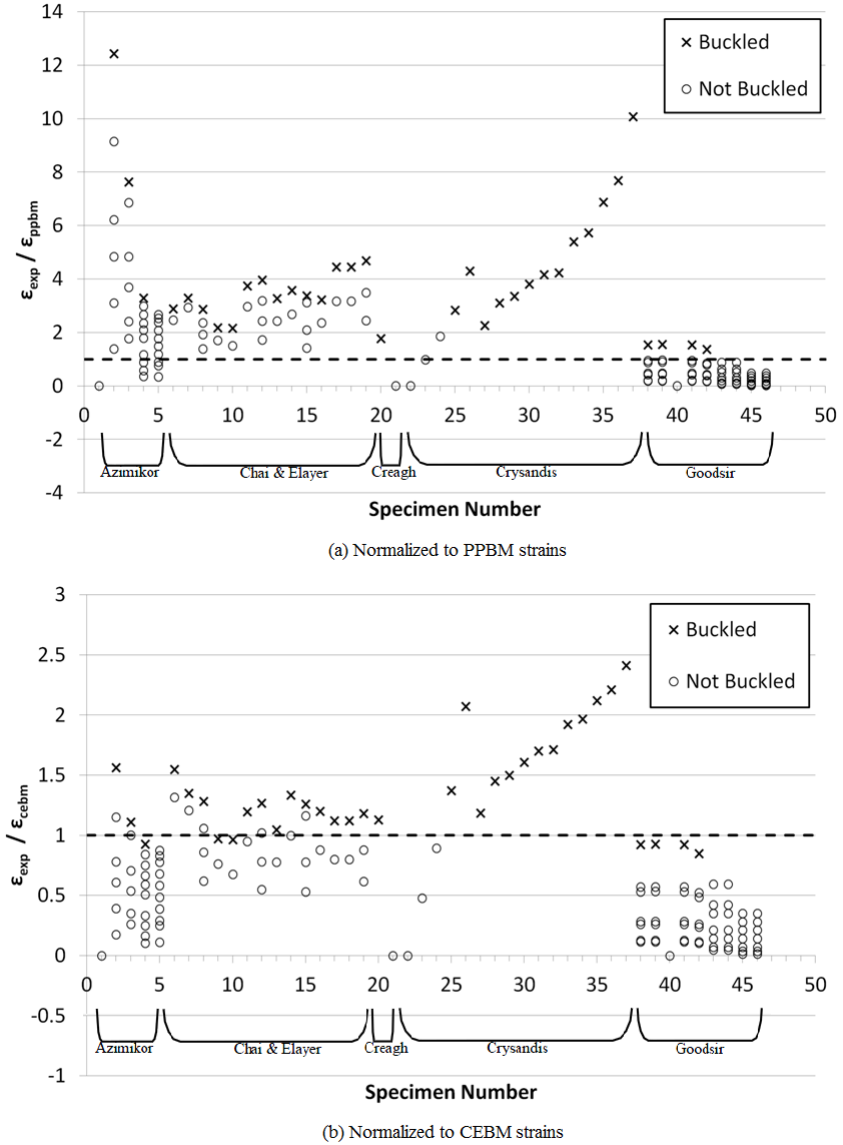
A complimentary analysis was conducted in the same study. Considering the PPBM and CEBM models, Herrick (2014) established a failure limit state related to the sustainable buckling tensile strains for some of the prisms mentioned before in this document. Once the experimental tensile strains were identified for each case, they were compared with the predicted values demonstrating that the PPBM shows more discrepancy than the CCBM, which can be perceived from Figure 9.

Figure 9 Experimental prism strains normalized to PPBM and CEBM strains. (Herrick, 2014)
